Lakes380

LAKE KUWAKATAI

Region: Auckland **Location:** Kaipara South Head **Coordinates:** 36° 31'48" S 174° 13'56" E **Depth:** 16 m

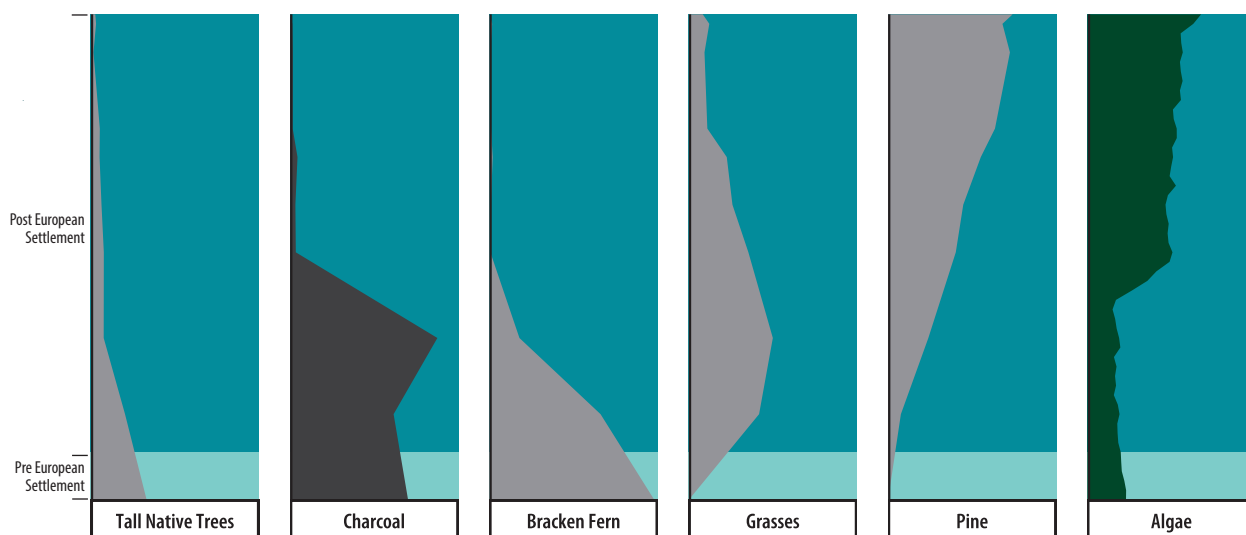
POLLEN, CHARCOAL AND ALGAE LEVELS FOR THE PAST ~250 YEARS

The graphic below shows high amounts of charcoal (indicating fire) and the presence of bracken fern and tutu, often associated with

vegetation modification. This suggests the vegetation on the land around the lake was experiencing significant disturbance about 250 years ago.

This graphic indicates the changes in abundance of plants, charcoal and algae through time.

The Lake Kuwakatai sediment core is sandy at the base. The base covers the period of the beginning of European settlement in the region. Initial results from the sediment core suggest that at this time the land around Lake Kuwakatai was dominated by bracken fern, the native shrub tutu and several varieties of fern, with a few tall native trees in the immediate catchment.

Post European settlement, vegetation change continued as pasture and exotic pine trees were planted in the catchment replacing most native species.

Algae have always been present in the lake and have increased in the last 50 to 100 years.
